# Electrical Grounding and Cathodic Protection Issues in Large Generating Stations

**■ The common bonding of underground ferrous structures to massive copper grounding grids creates problems for corrosion engineers and their attempts to provide cathodic protection to ferrous structures. This article discusses conflicts between the design and operation of copper and ferrous underground systems and presents alternatives. It describes the case of a large electrical generating station with a bare copper grounding grid, typical of late-1960s construction practices.**

## Case History— Steam Electric Station

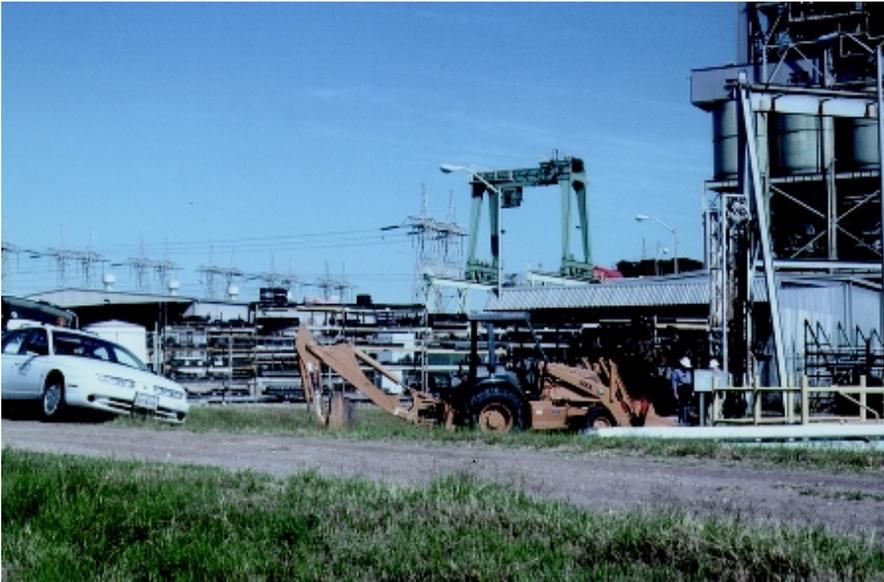
FIGURE 1

Typical construction activity, not related to CP work. Such construction may damage buried CP components.

This plant site has been subjected to considerable construction activity since startup (Figure 1). Much of the construction activity has been associated with mandated environmental and

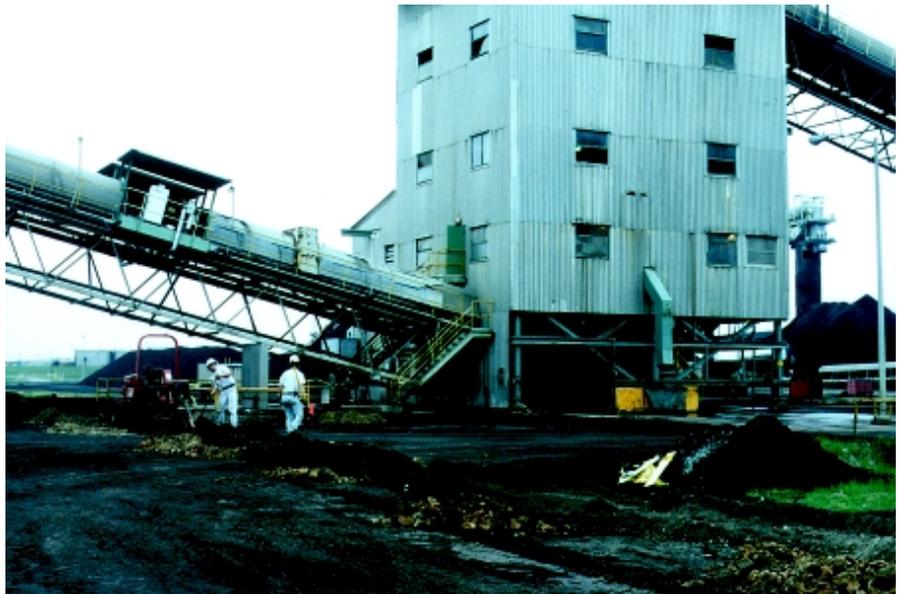
FIGURE 2

Repairs being made on a CP groundbed at the generating station.

The author began working with the plant's CP system in the mid 1990s after a number of water lines had been replaced because of corrosion failures. At that time, the CP system was in a general state of disrepair plantwide. The first course of action was to conduct a comprehensive CP survey. The existing rectifiers and/or anode-beds were then repaired over a 4-year period (Figure 2).
