Electrical Grounding and Cathodic Protection Issues in Large Generating Stations

EARL L. KIRKPATRICK, *ELK Engineering Associates, Inc.*

■ The common bonding of underground ferrous structures to massive copper grounding grids creates problems for corrosion engineers and their attempts to provide cathodic protection to ferrous structures. This article discusses conflicts between the design and operation of copper and ferrous underground systems and presents alternatives. It describes the case of a large electrical generating station with a bare copper grounding grid, typical of late-1960s construction practices.

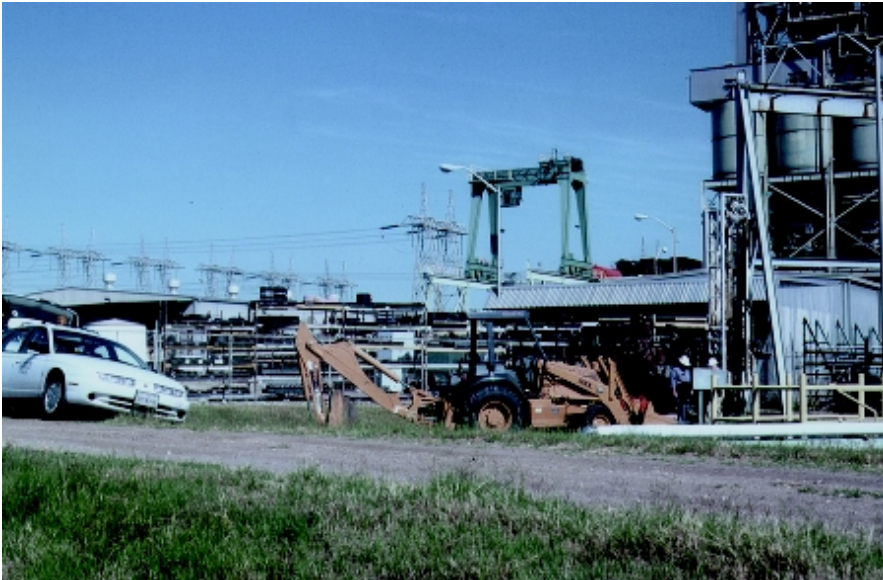
FIGURE 1

Typical construction activity, not related to CP work. Such construction may damage buried CP components.

This plant site has been subjected to considerable construction activity since startup (Figure 1). Much of the construction activity has been associated with mandated environmental and

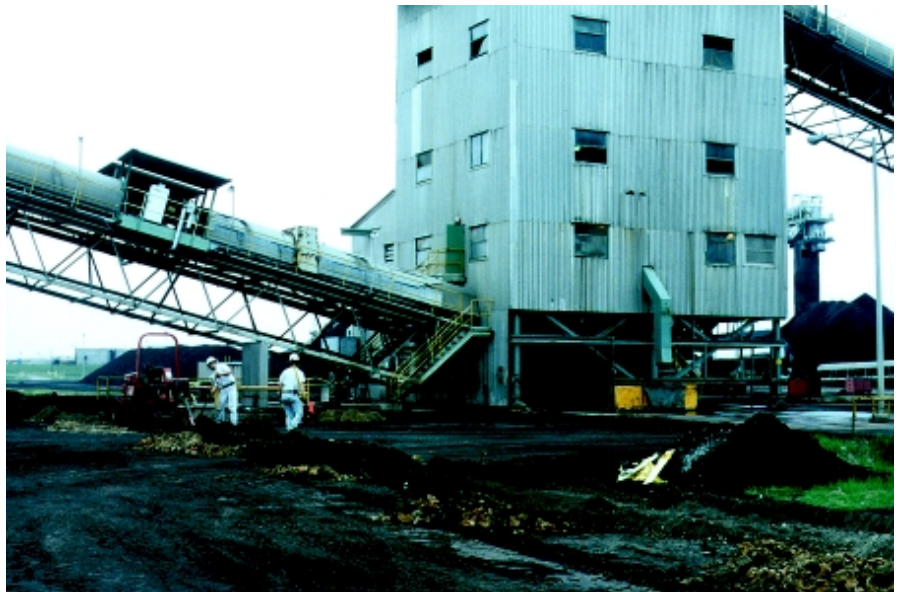
FIGURE 2

Repairs being made on a CP groundbed at the generating station.

The author began working with the plant's CP system in the mid 1990s after a number of water lines had been replaced because of corrosion failures. At that time, the CP system was in a general state of disrepair plantwide. The first course of action was to conduct a comprehensive CP survey. The existing rectifiers and/or anode-beds were then repaired over a 4-year period (Figure 2).
